## **Case Study – Reverse Engineering**

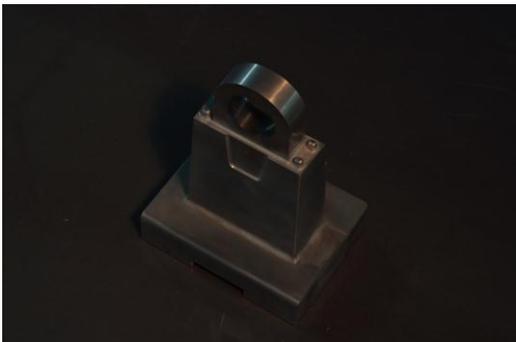
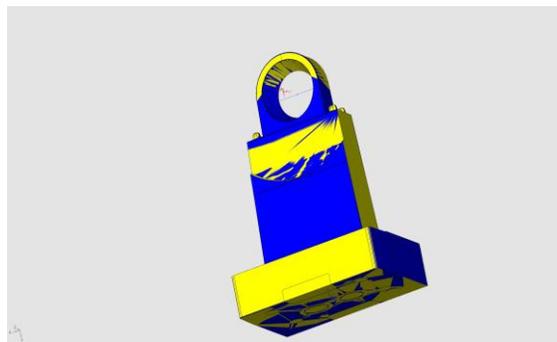
Maximum Mold worked with our customer to nail down our reverse engineering process. Our customer supplied us with a new slide core from a Die Cast Die, and a good 3-D model of the slide core for reference. With this new slide core we set out to create reliable, accurate data. We had this slide core Laser scanned without any data supplied, with this data we were able to create a new 3-D model of the slide core.

After we completed our new model from the scanned data we over-laid the new model to the model provided for a comparison. What we found was deviations of .013mm-.038mm (.0005”-.0015”). These dimensions put us well within our customer’s tolerance goals for this part.
